Manhole Inspection Summary

Manhole # S13GG1013MH

Location Address: **4240 REISTERSTOWN RD** Cross Street: **CLASSEN AVE**

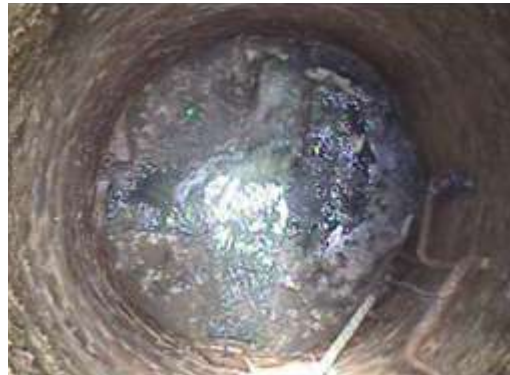
Top View

DEBRIS ON BENCH AND CHANNEL

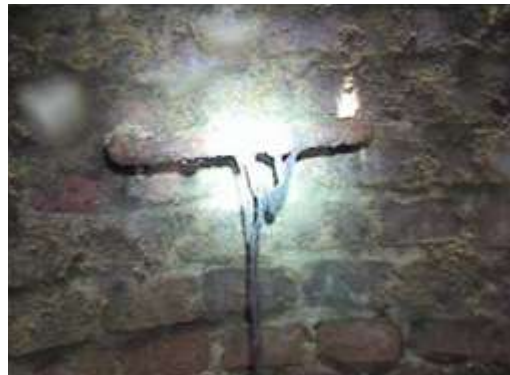
Defect 1

Steps Count: **6** Missing: **0** ☒ **Corroded**

Surcharge ☒ **Evidence Of Surcharge** Depth: **3.5** (ft.) ☐ Active Surcharge Present

SURCHARGE EVIDENT AND
CORRODED STEPS

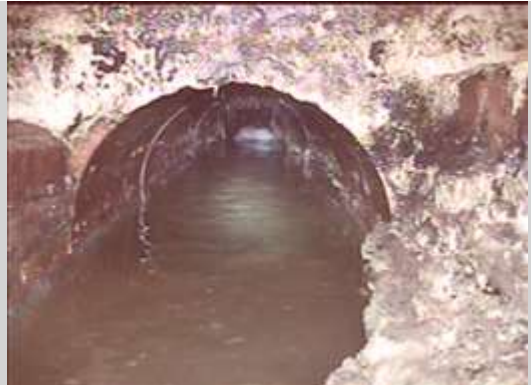
12 O'Clock Outflow

Pipe Height: **9.6** (in.) Rod and Bar (Angled)
Pipe Material: **Clay** ☐ Pipe Lined
Invert Depth: **10.59** (ft.) Flow Characteristics: **Fast**
Deposits: ☐ None ☐ Mud ☒ **Sludge** ☒ **Debris** ☒ **Grease**
Silt Depth: **6** (in.) Deposits Extent: **Heavy**
Infiltration: **Evidence** Pipe Seal Cond: **Sound**

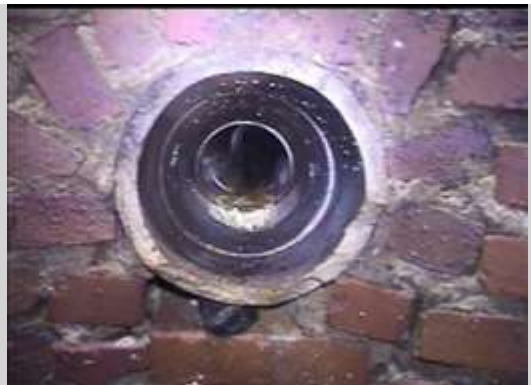
6 O'Clock Inflow

Pipe Height: **9.6** (in.) Rod and Bar (Angled)
Pipe Material: **Clay** ☐ Pipe Lined
Invert Depth: **8.79** (ft.) Flow Characteristics: **None**
Deposits: ☒ None ☐ Mud ☐ **Sludge** ☐ **Debris** ☐ **Grease**
Silt Depth: (in.) Deposits Extent:
Infiltration: **None** Pipe Seal Cond: **Sound**

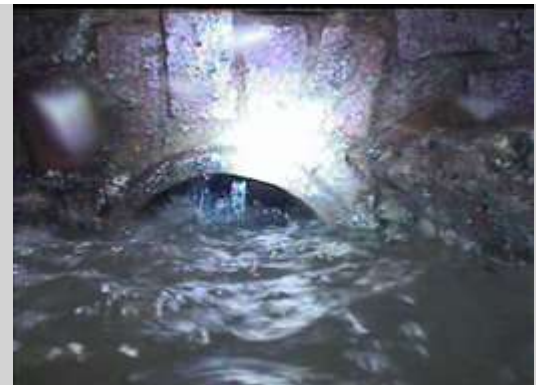
Drop In @ 6 O'Clock

SURCHARGE EVIDENT

Drop: **Outside** Rod and Bar
Angled: **Yes** Reading: **9.30** (ft.)
Inv Depth: **10.30** (ft.)
Drop Condition: **Open**

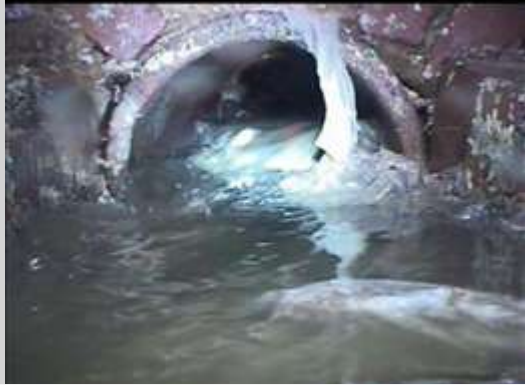
9 O'Clock Inflow

Deposits: ☐ None ☐ Mud ☒ ~~Sludge~~ **Debris** ☒ **Grease**

Silt Depth: **6** (in.) Deposits Extent: **Heavy**
